# Manhole Inspection Summary

Manhole # S25YY\_019MH

**Location** Address: **1311 CLIPPER HEIGHTS AVE** Cross Street: **SWEET AIR ST**

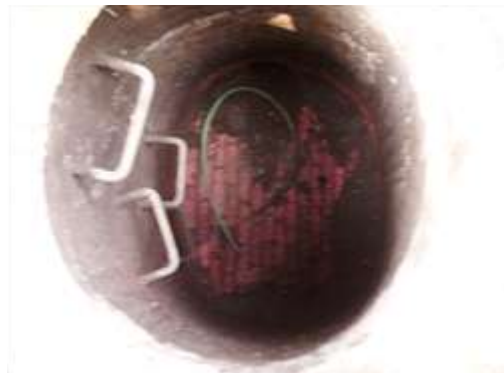
Top View

Channel debris.

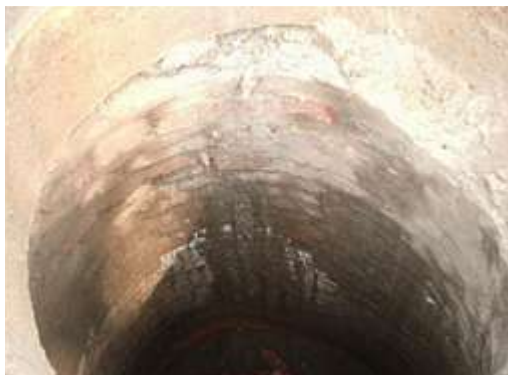
Defect

**Frame** Offset: **3** (in.) Condition: ☐ Sound ☐ Cracked ☒ **Leaks**

**Chimney / Frame Adjustment** ☒ Exists Material: **Brick** ☐ Parged Height: **6** (in.)  
Condition: ☐ Sound ☐ Cracked ☐ Root Intrusion ☐ Loose Brick ☒ **Deteriorated**  
Infiltration: ☐ None ☒ **Joint** ☐ Cracks ☐ Mortar ☐ Roots ☒ **Wall**

**Corbel** Material: **Brick** ☐ Parged Type: **Concentric/Eccentric**  
Condition: ☒ Sound ☐ Cracked ☐ Root Intrusion ☐ Loose Brick ☐ Deteriorated  
Infiltration: ☐ None ☐ Joint ☐ Cracks ☐ Mortar ☐ Roots ☒ **Wall**

**Barrel** Material: **Brick** ☐ Parged  
Shape: **Circular** Diameter: **42** (in.) Length: (in.)  
Condition: ☒ Sound ☐ Cracked ☐ Root Intrusion ☐ Loose Brick ☐ Deteriorated  
Infiltration: ☐ None ☐ Joint ☐ Cracks ☐ Mortar ☐ Roots ☒ **Wall**

Frame leaks. Frame offset. Adjustment deterioration and infiltration. Corbel and Barrel infiltration - other side.

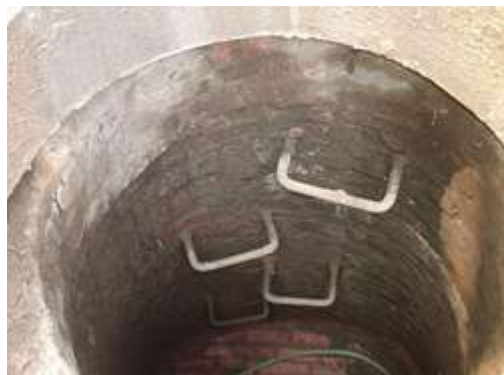
Defect

Frame leaks. Frame offset. Adjustment deterioration and infiltration. Corbel and Barrel infiltration.

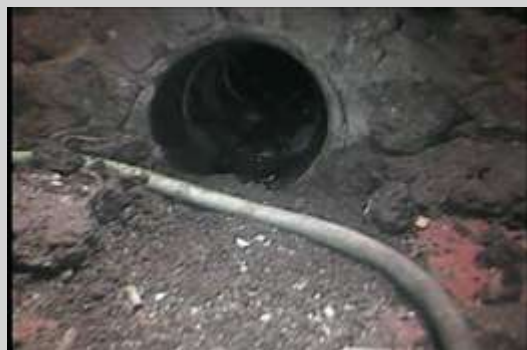
Pipe Out @ 12 O'Clock

Deposits: ☐ None ☒ **Mud** ☐ Sludge ☒ **Debris** ☐ Grease

Infiltration: **Evidence**

Pipe Seal Cond: **Cracked**
